Manhole Inspection Summary

Manhole # **S15GG_020MH**

Location Address: **1641 ASHBURTON ST**

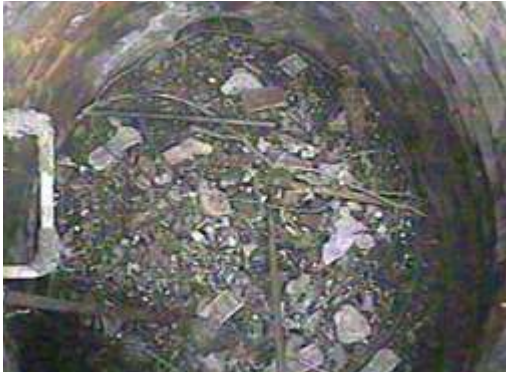
Defect 1

Condition: ☐ Sound ☐ Cracked ☐ Root Intrusion ☐ Deteriorated ☐ Leaks ☒ **Debris**

debris on channel

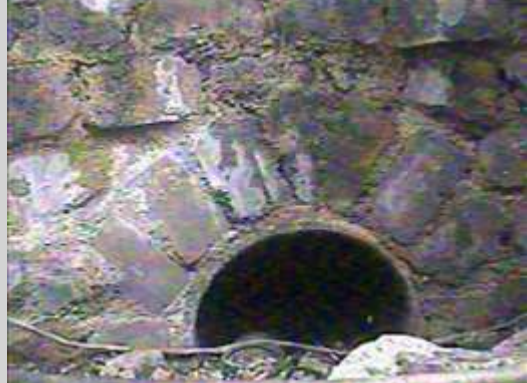
12 O'Clock Outflow

8 in. Circular Gravity Sewer
Pipe Out @ 12 O'Clock

Deposits: ☐ None ☐ Mud ☐ Sludge ☒ **Debris** ☐ Grease

Silt Depth: **3** (in.) Deposits Extent: **Medium**
